Automatic Sprinklers: Sprinkler Hanger Dangers

No. FP-2009-30 July 28, 2009

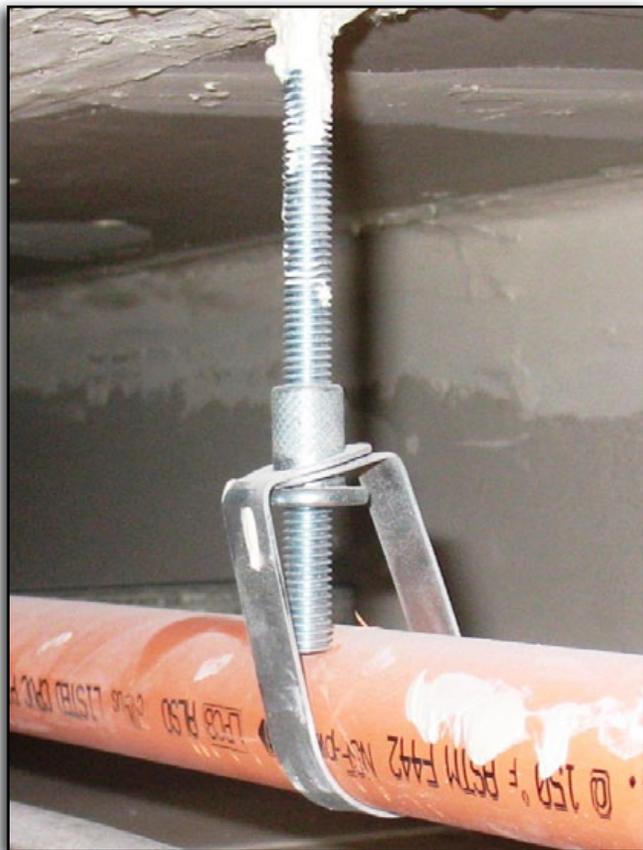
The listed hanger that supports the pipe has been tightened against the all-thread rod so much that one end of the rod is in direct contact with the plastic pipe. Over time, if the pipe expands and contracts due to thermal changes, moves due to water hammer or simply moves with the building, friction between the pipe and all-thread rod could wear a hole in the pipe.

However, CPVC pipe may be more susceptible to damage if it is not installed correctly or exposed to physical threats such as powder- or gun-driven anchoring devices, errant drill bits, and improperly installed hangers like this one.

The pipe manufacturer's technical literature specifically warns against this potential problem. It calls for a minimum 1/16-inch (1.6 mm) clearance between the rod tip and pipe.

Photo courtesy Rockville Fire Department, Maryland.
The contact between the all-thread rod and plastic pipe may lead to a leak.

While it may seem that looking closely at every hanger on a sprinkler system installation is a time-consuming effort, correcting a problem like this potential one may make it all worth it.
